Engineering News

NEW YORK, APRIL 24, 1913

The Recent Standpipe Failure at Cairo, Ill.

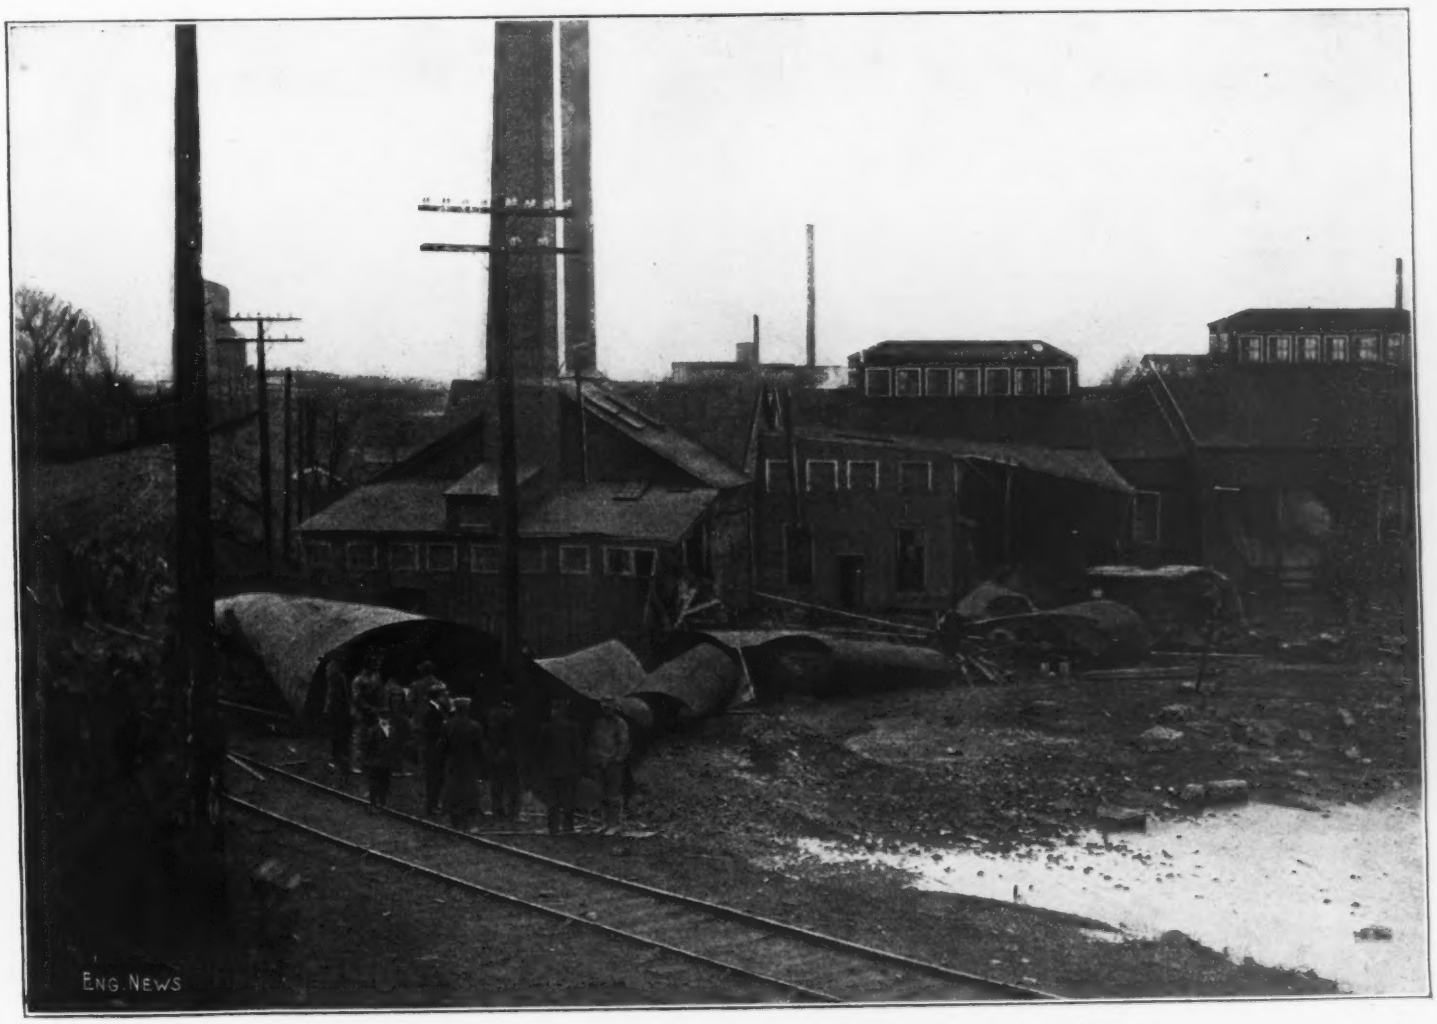
Fig. 1. General View of Wrecked Standpipe, Cairo, Ill.

across the Illinois Central R.R. tracks, blocking traffic for several hours and wrecking a freight car. The top section fell along the bank of the Ohio River and wrecked a small house boat. The bottom plate was detached from the side plates and left lying on the foundation. The location of the fallen standpipe is shown in Figs. 1 and 2. The section falling on the tracks was moved west of the tracks before the photograph reproduced as Fig. 1 was taken. Water from the standpipe, which was full at the time of the accident, was deflected by the foundation tered Ohio River water for more than two weeks. The condition of the foundation and plates just after the fall is shown by Figs. 1, 3, 4, 5, 6, 7 and 8.

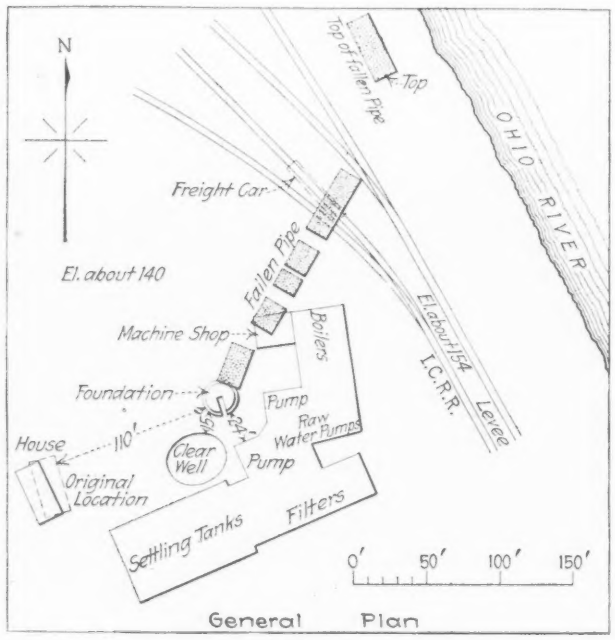
FIG. 2

The standpipe of the Cairo Water Co. fell at about 2:15 a.m., Feb. 11, 1913, as noted in Engineering News of Feb. 20, 1913. The standpipe was close to the pumping station and filter house, as shown in Figs. 1 and 2. It was built in 1885 by W. B. Maitland & Son, contractors, at that time of Peoria, Ill.

General Plan

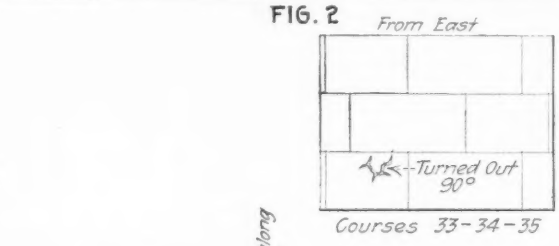
FIG. 4

Details of Torn Side Plates

There is a possibility that the first failure was in Course 33 from the bottom, where a plate was torn, and that the resulting reaction threw the standpipe to the west and increased the strain on the bottom plates on the west side, but it is more probable that this hole was caused by striking the house boat. The largest hole torn in the standpipe was on the west side, near the base, and it is probable the failure was at Point A as indicated in Fig. 4.

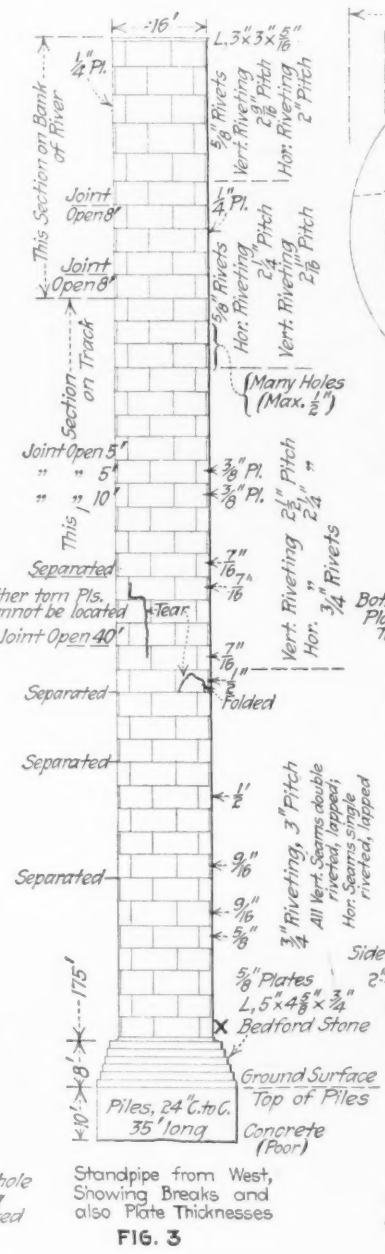
FIG. 3

Standpipe from West, Showing Breaks and also Plate Thicknesses

as shown in Figs. 1, 3, 4, 8, 9 and 10. Of the torn plates most of the damage must have been caused by the fall. The hole in Course 33, counting from the bottom, may have been caused by striking a corner of the house boat wrecked by the standpipe. In addition to the tears shown in Figs. 1 and 4 there were small tears in the lower courses of some sections evidently caused by striking the ground, a tear caused by striking the freight car, and some tears in plates not possible to locate in the sketch.

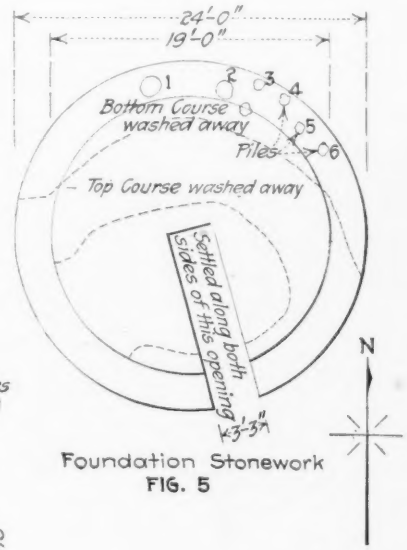
FIG. 5

Foundation Stonework

The upper part of the concrete of the foundation was very poor. A piece of wood molding was driven with a brick under the edge of the stone at an angle of about 30° with the vertical to the depth of 30 in. When withdrawn it was covered with black mud and grease. In the stonework there were some large spaces between the stones not entirely filled with mortar. The condition

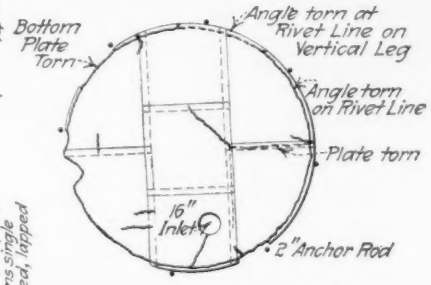
FIG. 6

Bottom Plate of Standpipe, Seams Double Lap Riveted, 3" Centers

The bottom plate of the standpipe was torn in several places, as shown in Fig. 6. The angle joining the bottom and side plates of the standpipe was of very poor steel and it was badly corroded in several places along the surface of contact with the bottom plate. The bottom edge of the lowest side plate was 2 in. above the bottom plate, bringing extra stresses on the angle joining the two. Views of pieces of the angle are given in Figs. 11 and 12.

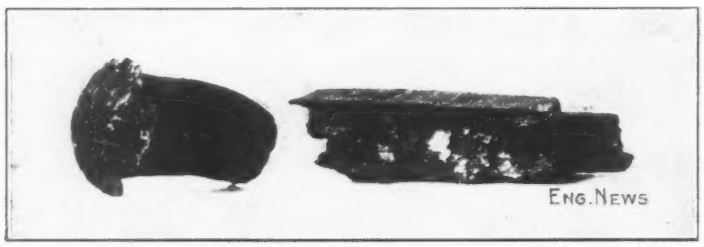
FIG. 11. RIVET AND PIECE OF ANGLE JOINING BOTTOM AND SIDE PLATES, CAIRO STANDPIPE, SHOWING CORROSION

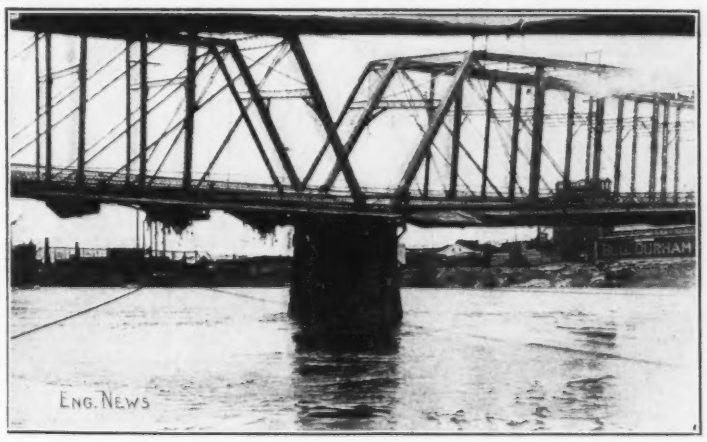
Fig. 6. Showing Settled West Pier

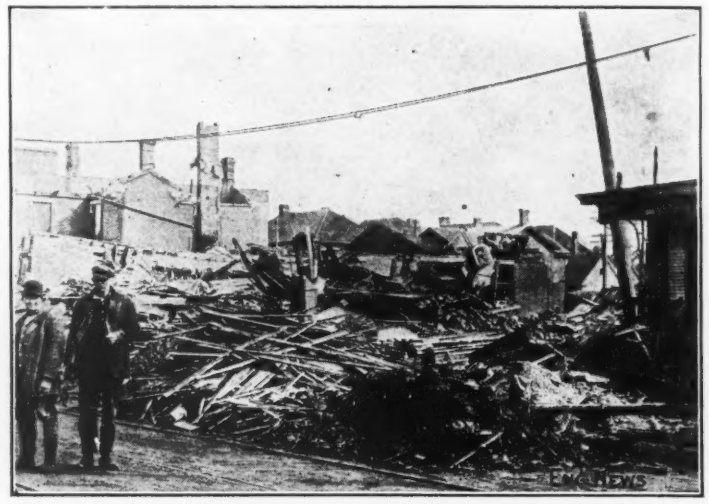
FIG. 3. VIEW ON SOUTH MAIN ST.

FIG. 4. VIEW LOOKING EAST ON FIFTH ST.

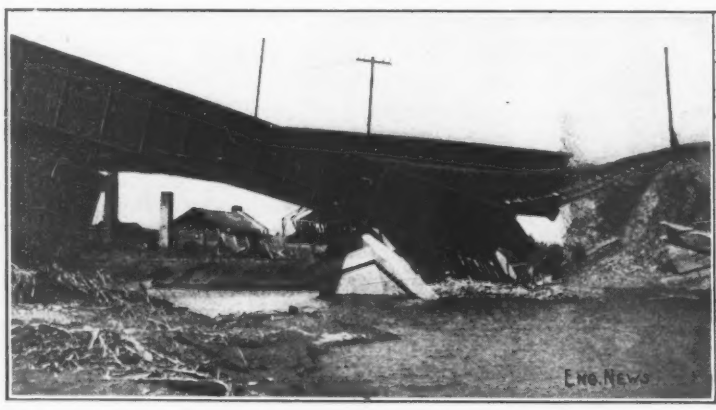
CROSSING OF OHIO ELECTRIC RY. OVER C. H. & D., BETWEEN TRENTON AND MIDDLETOWN

(Both abutments underwashed and broken; C. H. & D. temporary track run through on S-shaped alignment after hoisting wrecked span out of the way.)

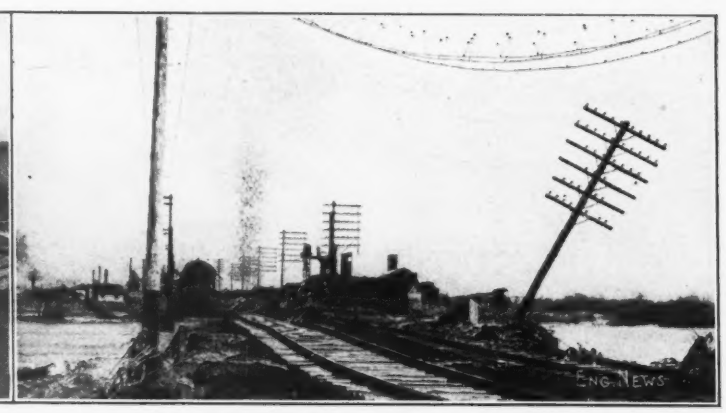
NEW RIVER BRIDGE OVER BIG MIAMI NORTH OF HAMILTON, INTACT

(Plate-girder spans, about 10 ft. depth of web. Water flowed 2-3 ft. over the tops of the girders. The L. H. & I. Ry. bridge, 2 mi. south, went out by undermining of the piers.)

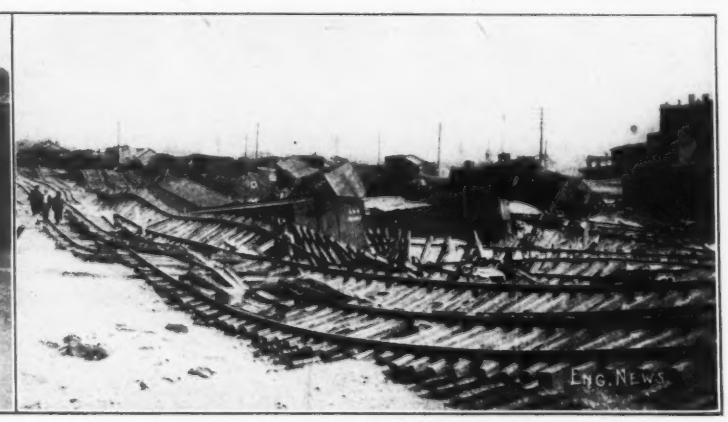
SOUTH HAMILTON YARD, AFTER THE FLOOD

(Roadbed under tracks scoured out some 15 ft.)
